Zoom Webinar March 21, 2024

### PFAS: A Time Bomb Underground

The military as the main responsible party for a global environmental disaster  
Karl-Heinz Peil

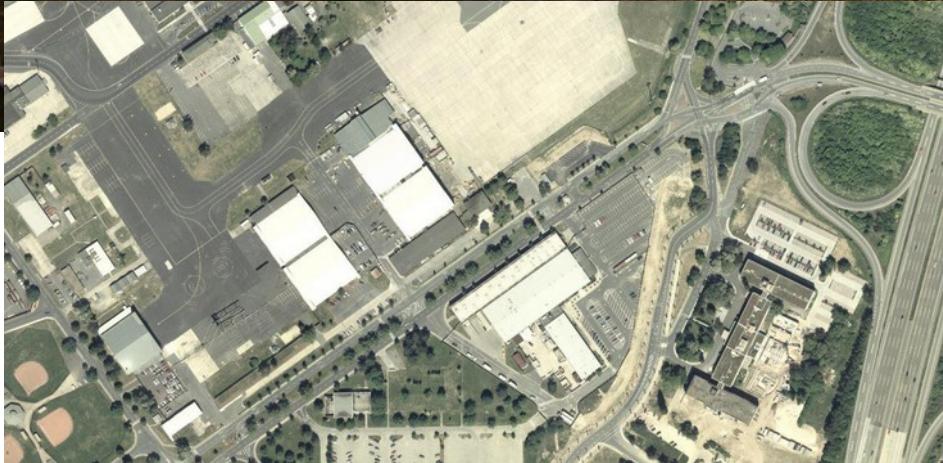
Picture:  
Air Base  
year 2000

- US Air Base Rhein-Main until 2005
- since 2008: Planning process to expand Frankfurt Rhine-Main with Terminal 3 (today still under construction)
- 2014: first pump & treat work at former fire-fighting training site
- 2020: Authority approval for temporarily storage of contaminated soil on the construction site
- "final disposal" at various sites distributed over Germany is likely to prove to be a negative example of "waste tourism."

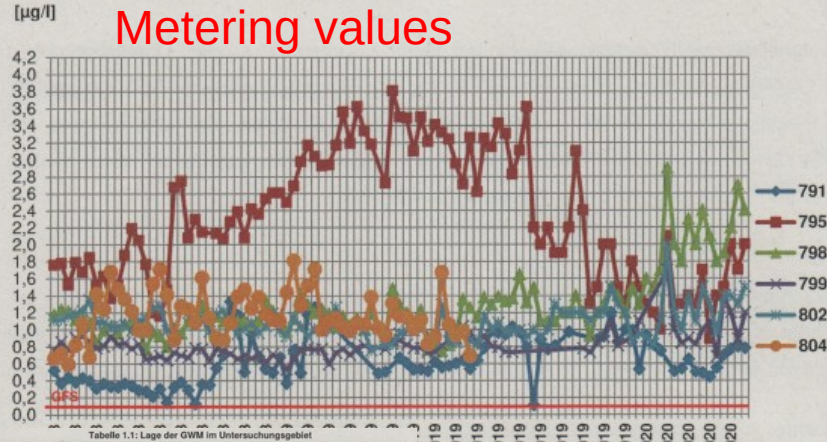
## Monitoring of ground water / Metering values

GWM	Rechtswert [m]	Hochwert [m]	POK [m NN]	Ausbauflie [m]
791	3469970.44	5543904.34	99.24*	-5.93*
795	3470167.57	5543830.86	105.63	-16.08
798	3470220.06	5543717.93	105.26	-15.74
799	3470154.12	5543659.24	104.63*	-15.96*
802	3470088.69	5543598.53	105.01*	-15.27
804	3469972.71	5543653.13	105.64	-15.86

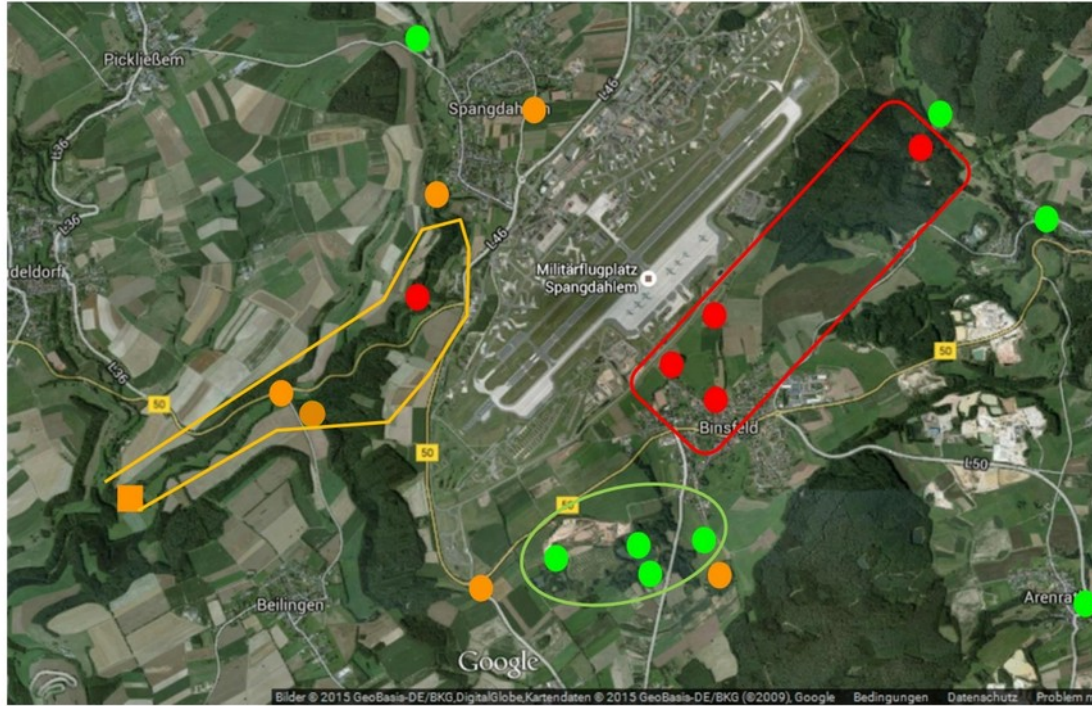
PFT-Werte: grün = gering; orange = mittel; rot = hoch (<http://sgdnord.rlp.de/>) <https://www.google.de/maps/@49.9718418,6.6843993,5490m/data=!3m1!1e3>  
Dr. Friederike Kremb-Wagner (16.10.2015)

- largest PFAS contamination in the surroundings of a US airfield in Germany
- PFOS fire foams used until 2010
- 2010: examination of soil by order of US military
- 2011: water management authorities start with monitoring PFAS
- 2015: closing of a drinking water well, authorities give a warning for fish for various bodies of water
- 2020: authorities demand a risk analysis and measures for remediation

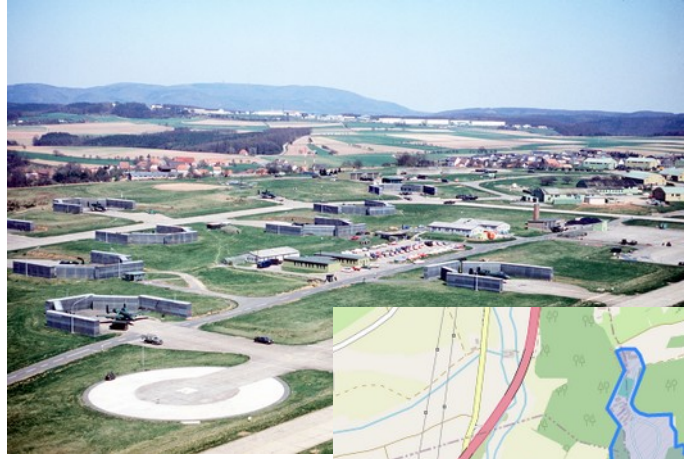
- former Airfield Sembach was closed 1995  
- conversion to a business park in progress
- initial ground investigations detected mineral oil contamination only
- contaminated soil was dredged, spread on the old runway and cleaned up by biological treatment
- PFAS contamination was detected later and supposedly successful remediation turned out to be a serious mistake
- controversial consequence: large-scale sealing of all designated commercial areas  
- so rainwater does not penetrate PFAS-contaminated soil
- several drinking water wells already had to close
